Environmental Assessment

Perennial Rio Grande Silvery Minnow Refugia at Drain Outfalls

U.S. Department of the Interior
Bureau of Reclamation
Albuquerque Area Office

July 2007

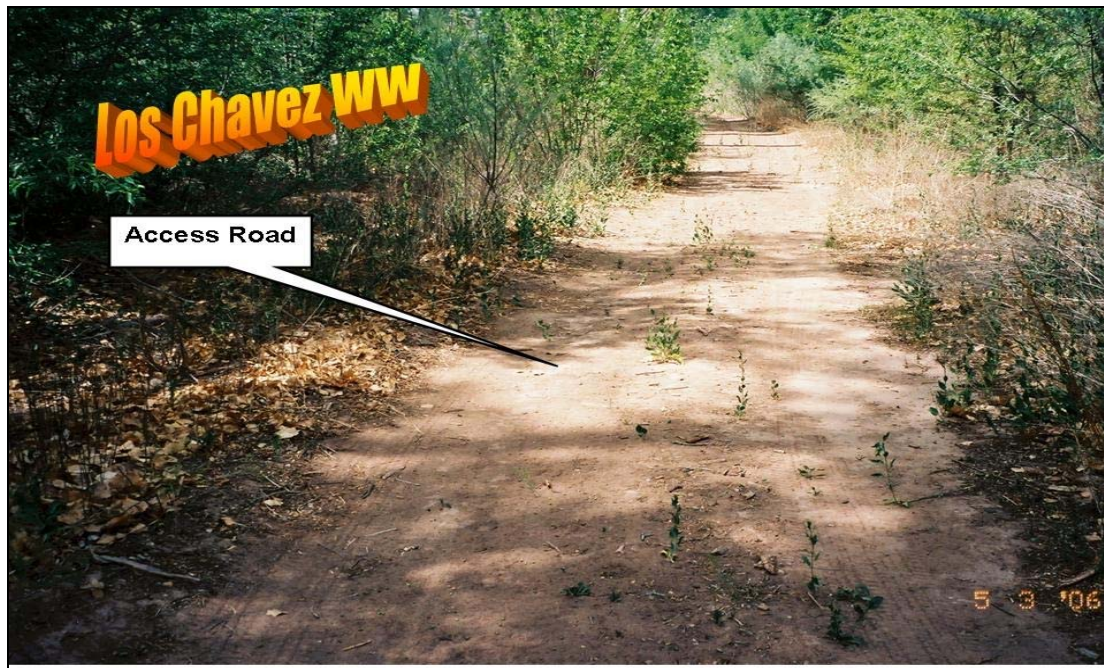
Figure 6. Access road to the Los Chavez Wasteway drain outfall.

Access to the Los Chavez Wasteway is via an existing road (Fig. 6). Recreational and river management activities have kept the road clear of brush and debris and no vegetation removal will be required.

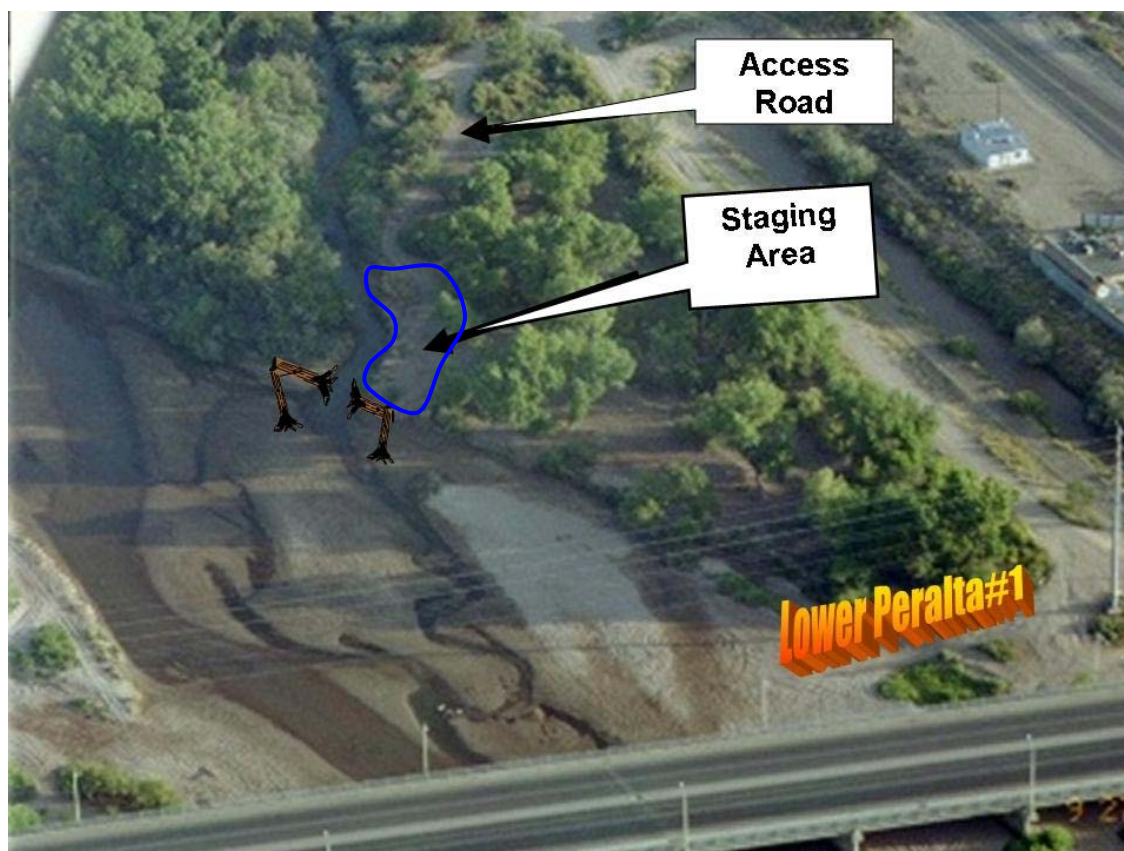
Figure 13. Location of the access road and staging area for the Lower Peralta #1 Drain.
